Manhole Inspection Summary

Manhole # S37M__012MH

Insp Date: **8/28/08 11:09 AM**

Location Address: **rusty scupper**

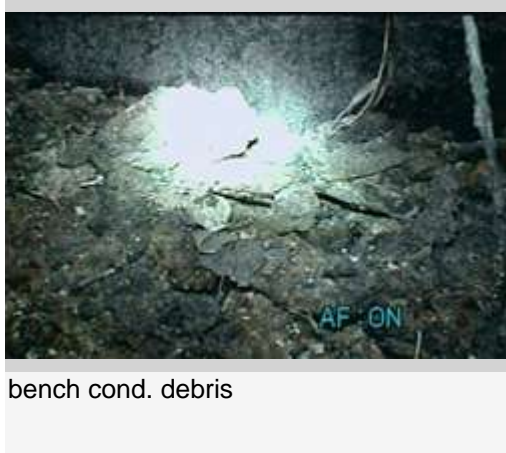
Defect 3

Condition: ☐ Sound ☐ Cracked ☐ Root Intrusion ☐ Deteriorated ☐ Leaks ☒ **Debris**

bench cond. debris

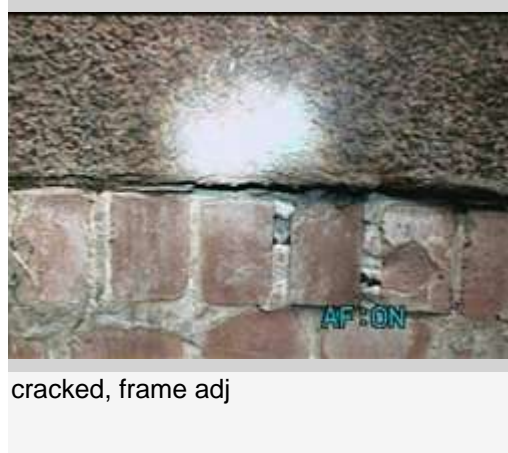
Defect 2

Condition: ☐ Sound ☒ **Cracked** ☐ Root Intrusion ☐ Loose Brick ☐ Deteriorated

cracked, frame adj

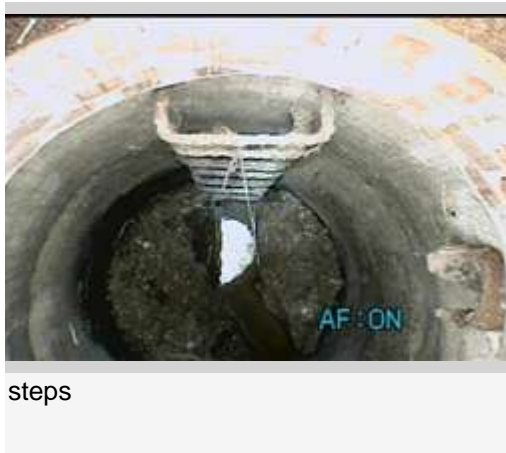
Defect 1

Steps Count: **7** Missing: **0** ☒ **Corroded**

steps

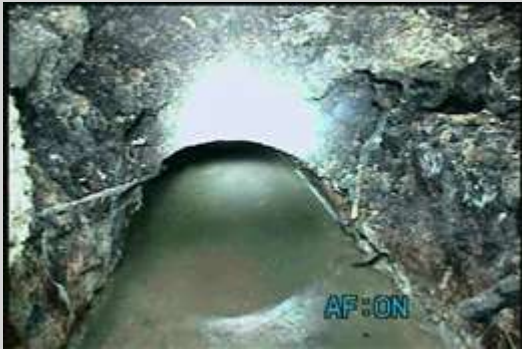
12 O'Clock Outflow

8 in. Circular Gravity Sewer
Pipe Out @ 12 O'Clock

Pipe Material: **Clay** ☐ Pipe Lined

Invert Depth: **10.33** (ft.) Flow Characteristics: **Slow**

Infiltration: **None** Pipe Seal Cond: **Unknown**

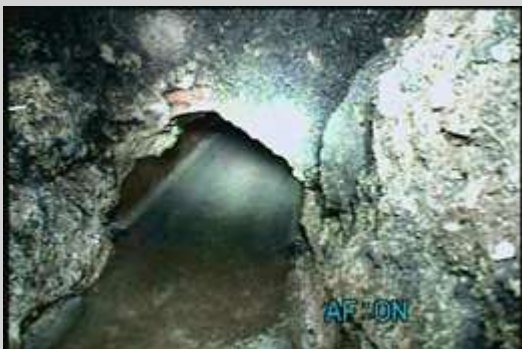
7 O'Clock Inflow

8 in. Circular Gravity Sewer
Pipe In @ 7 O'Clock

Pipe Material: **Clay** ☐ Pipe Lined

Invert Depth: **10.16** (ft.) Flow Characteristics: **Slow**

Infiltration: **None** Pipe Seal Cond: **Unknown**

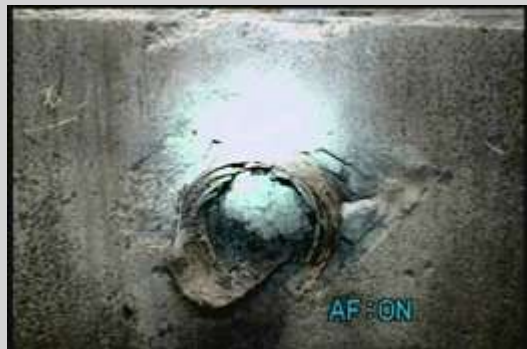
9 O'Clock Inflow

6 in. Circular Gravity Sewer

Pipe In @ 9 O'Clock

Invert Depth: **2.75** (ft.) Flow Characteristics: **None**

Connects To: **Stub connection / abandoned**
